CHURCH OF THE HOLY SEPULCHRE JERUSALEM

STRUCTURAL SURVEY
FINAL REPORT

BY
WILLIAM HARVEY

1935

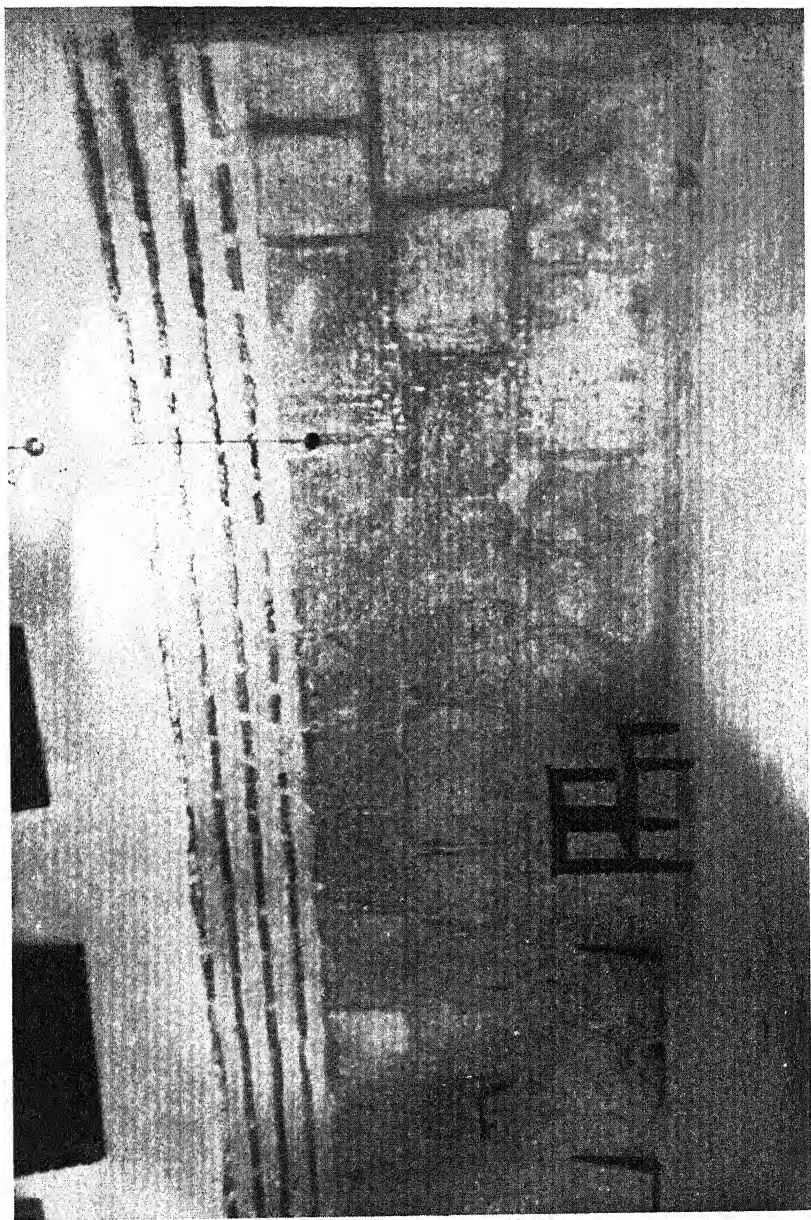
FIG. 68. BYZANTINE OUTER WALL OF ROTUNDA IN UPPER GALLERY

The galleries of the Rotunda (see Fig. 67) surround the main piers, and are enclosed by a circular wall, whose lower portions date from Constantine's original Anastasis (see Fig. 68). This circular wall leans outwards owing to the thrusts of the gallery vaults and the communicated thrusts of the cone which covered the central space prior to 1808.

A series of tie-bars across the arches of the upper Rotunda gallery, connected to a band of reinforcement in the outer wall may also be required to stabilize this wall and the inner colonnade.

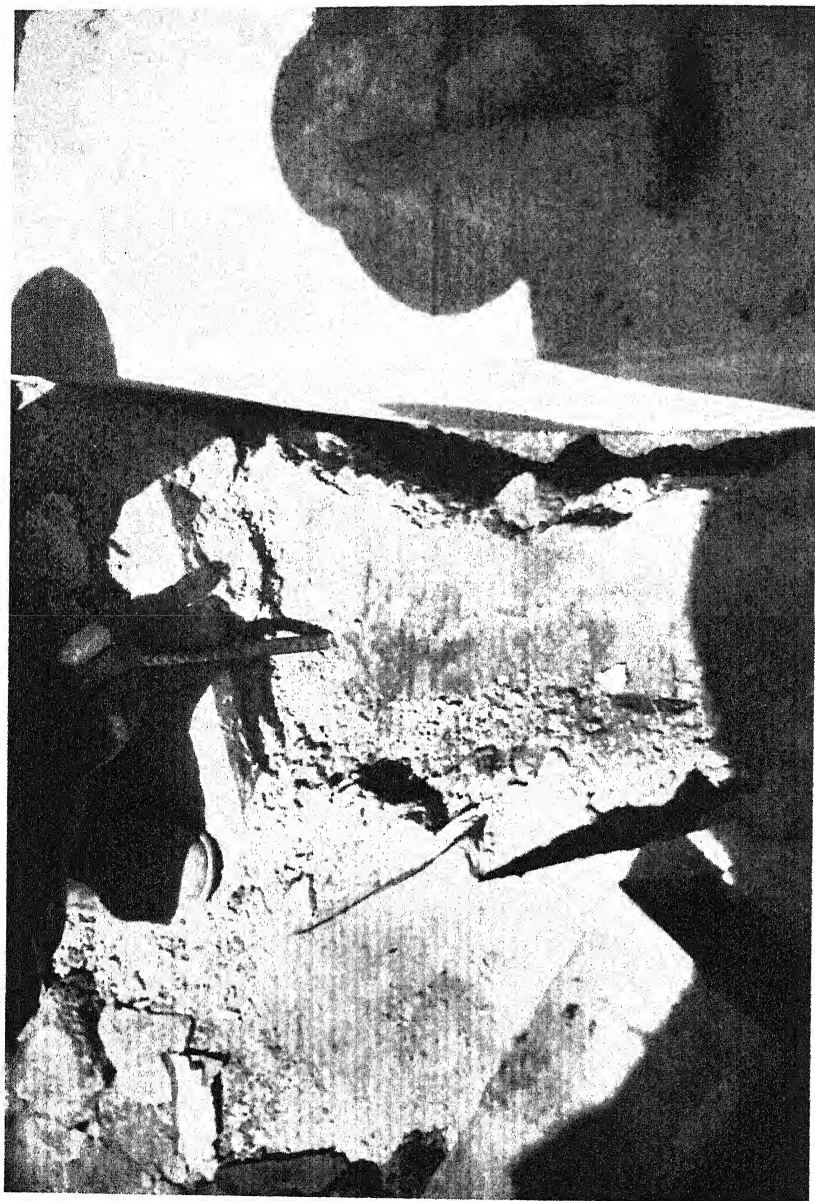
The roofs in general are in a bad state, and allow much rain-water to penetrate to the interior. As previously mentioned this has led to much extra weight being imposed on the building as successive layers of roofing material have been laid (see Fig. 69).

FIG. 69. PORTION OF HIGH VAULT ROOF, SHOWING SUPERIMPOSED
LEVELS OF SLABS

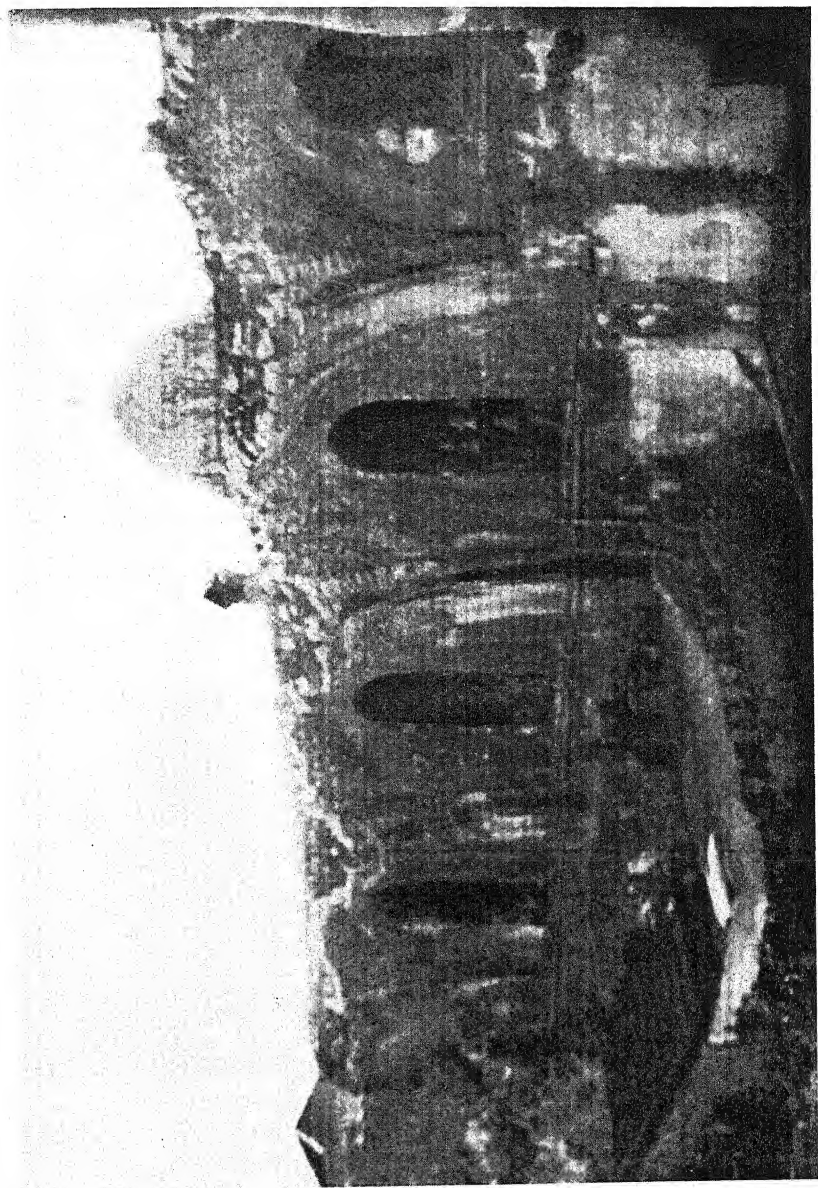
Secondly, the major part of the South wall of the old Latin Refectory (see Figs. 70, 71, II, 14) is in a ruined state, with large masses of overhanging vaulting. These are cracking away from the wall, and there is grave danger of their collapse.

FIG. 70. RUINED SOUTH WALL OF OLD REFECTORY

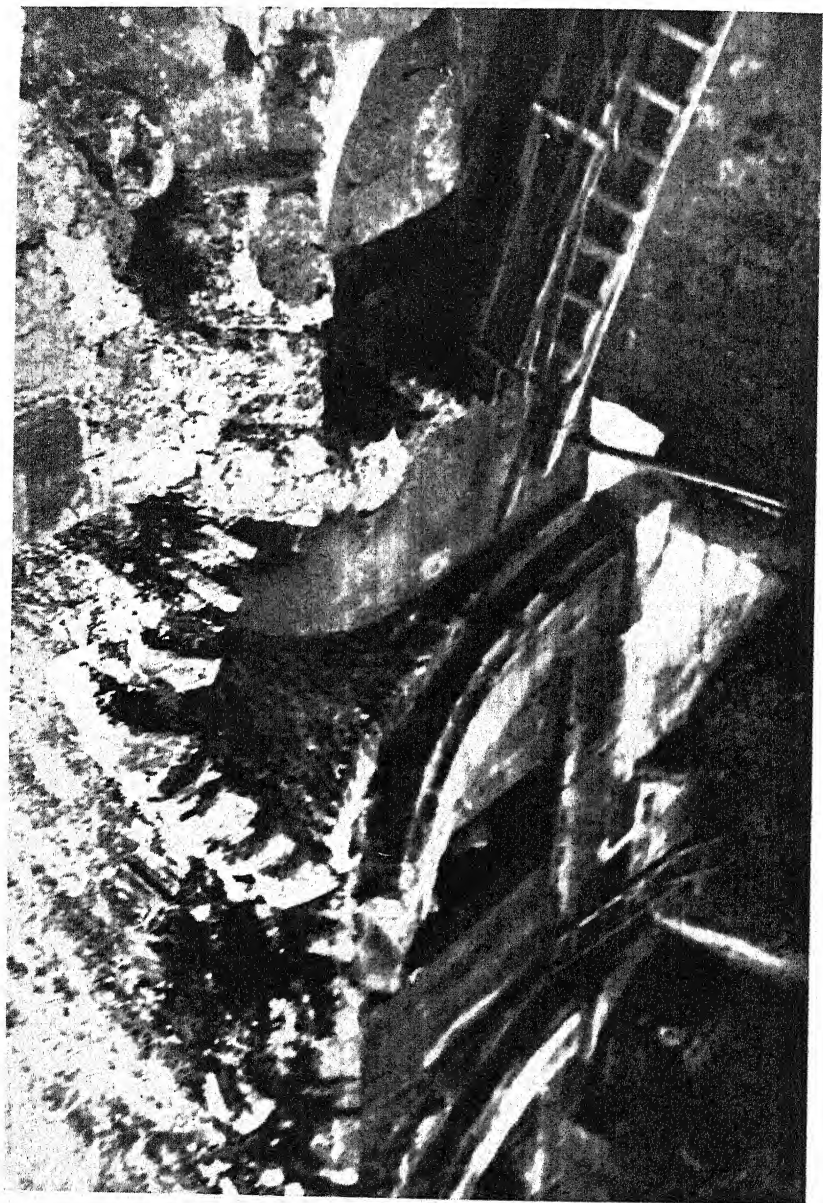
FIG. 71. OVERHANGING VAULT MASSES OF OLD REFECTORY

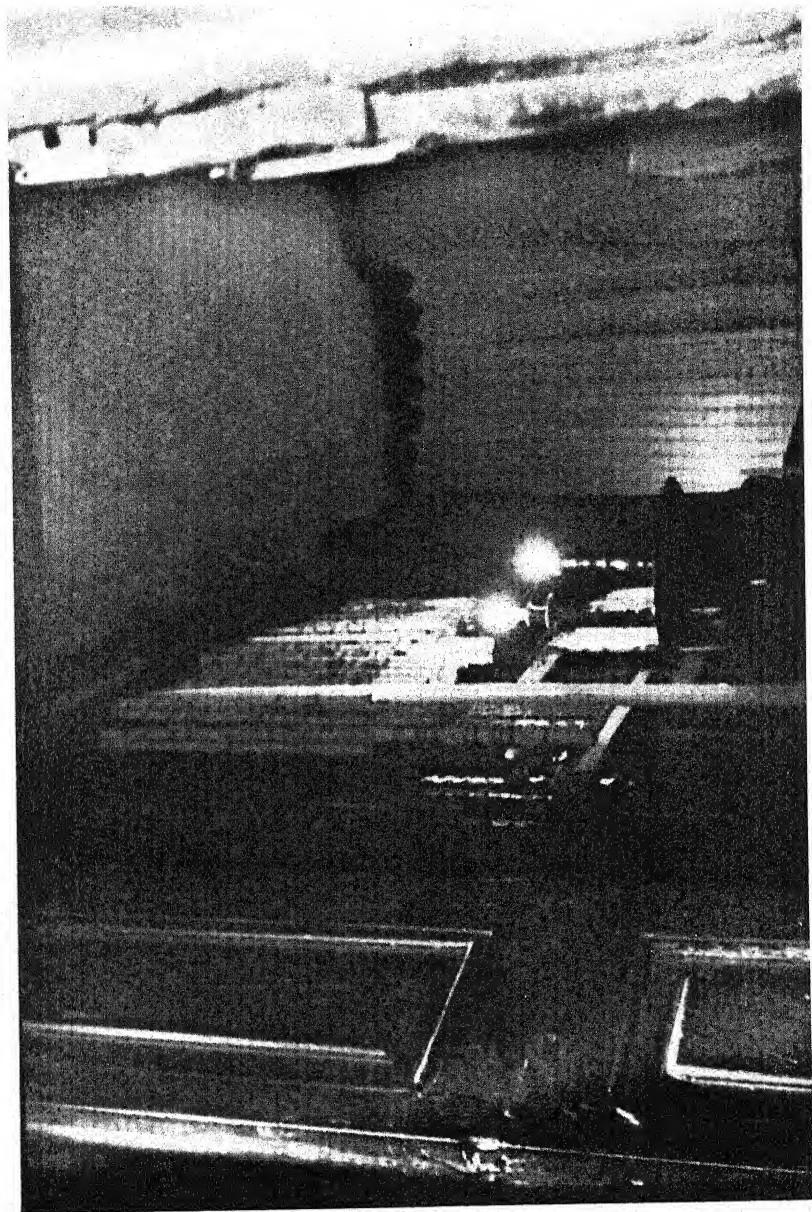
produce another such conflagration. Many of the small rooms which have been formed in the aisle of the Rotunda (see Figs. 72, I, 23) are used as stores for miscellaneous property, including large quantities of candles and oil. As there is much dry and decaying timber adjacent, a fire could easily be started, especially as only open lamps and candles are used for light in these rooms.

FIG. 72. CANDLE STORE IN OLD AISLE OF ROTUNDA

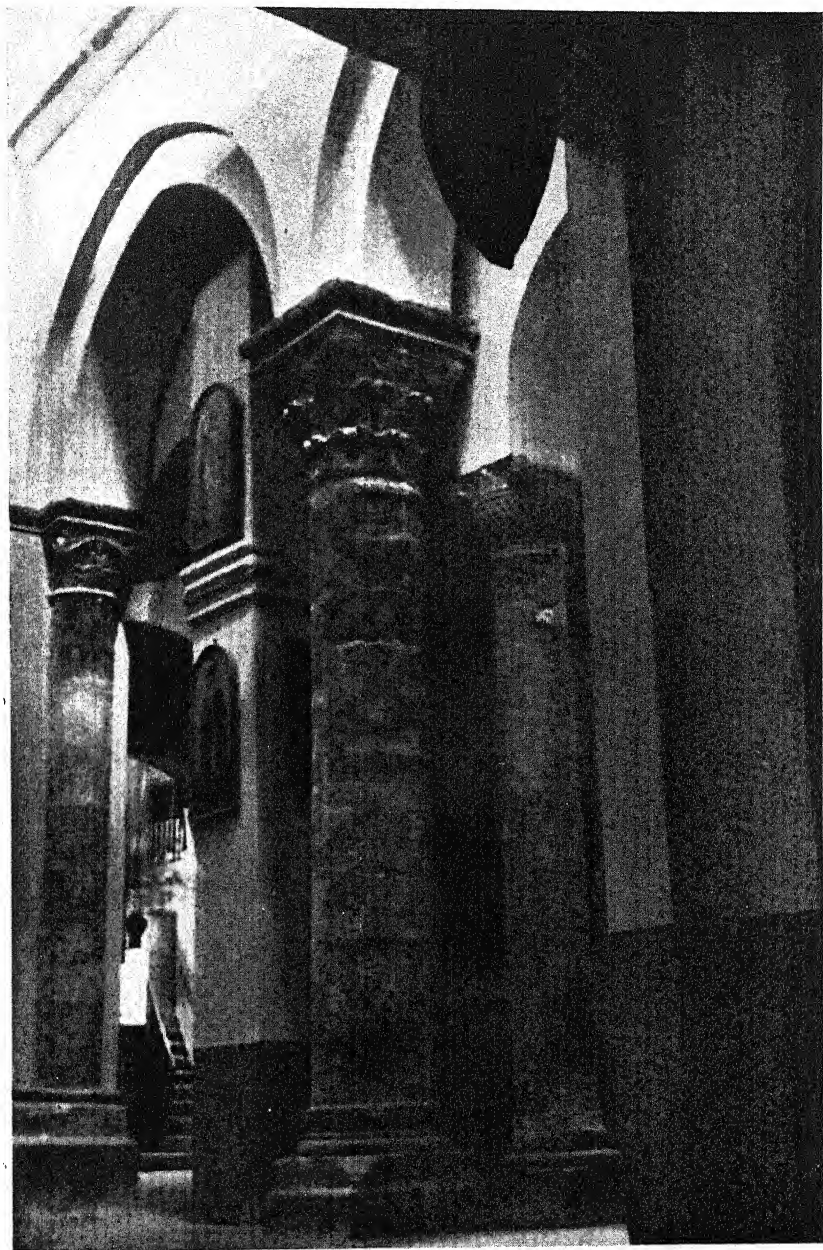
FIG. 73. PIERS OF NORTH TRANSEPT, SHOWING
MASONRY AND PLASTERED FACES

(1) An alteration which would affect the whole Church, though without changing the present arrangement, would be the stripping off of all plasterwork, thus revealing the original stone faces, which would then be carefully washed. As very large portions of the plasterwork would in any case be removed during the work of repair, this would involve little extra labour, and would greatly improve the appearance of the interior. Special care would have to be taken to ensure that any traces of original mosaic or colouring would be preserved (see Figs. 73, 74, 75).

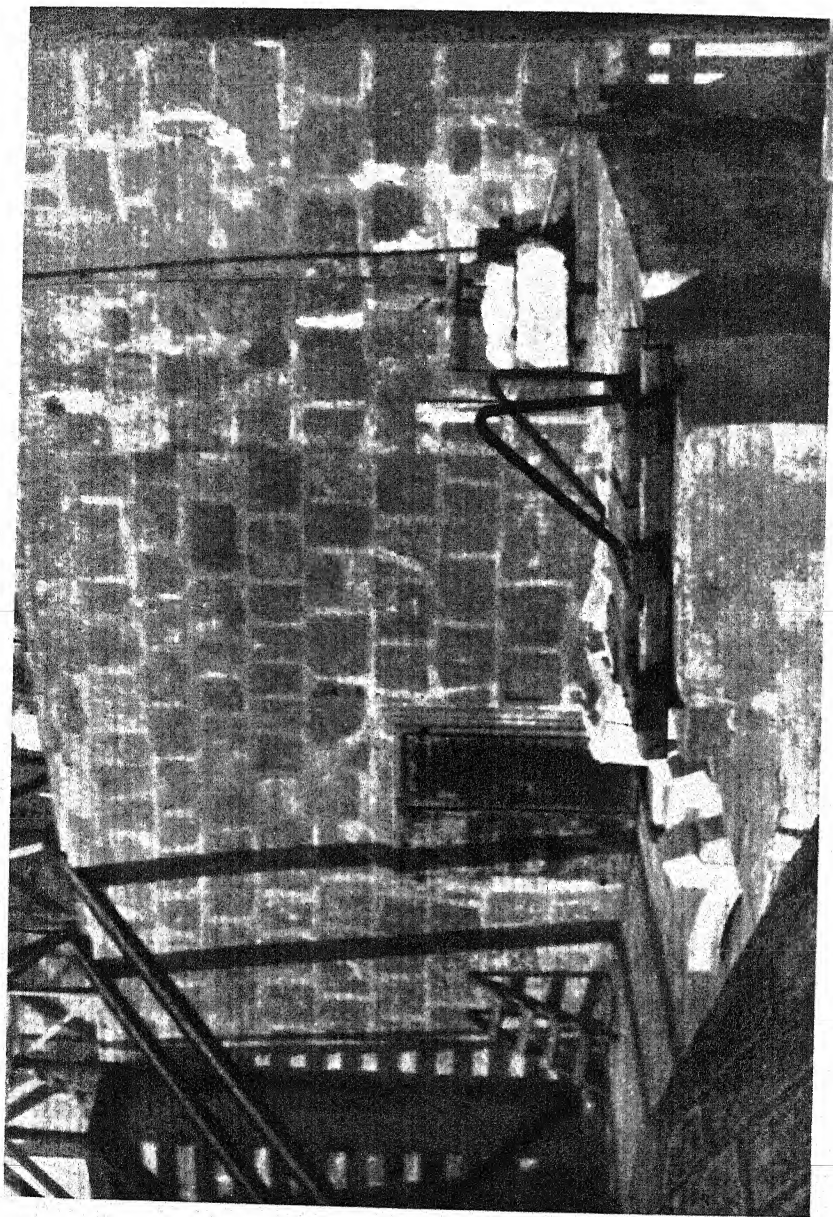
FIG. 76. WINDOW BLOCKED BY IRON DOORS

1. High vault North Transept West wall (1).
2. High vault East arm South wall (1) (see Fig. 76).
3. Ambulatory North-east apsidal chapel (2) (see Fig. 77).
4. Ambulatory centre apsidal chapel (3) (see Fig. 78).
5. Above stair to St. Helena's Chapel (1).
6. Ambulatory South-east apsidal chapel (2).

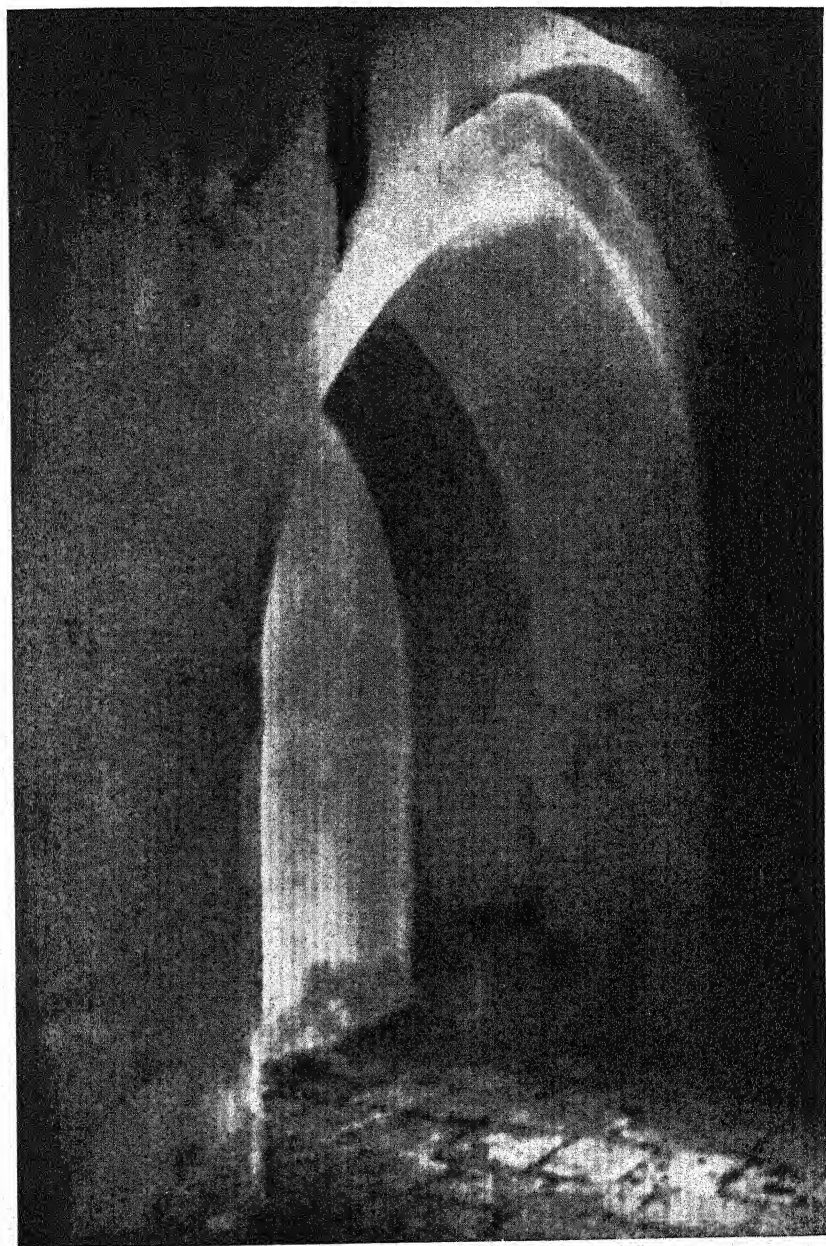
FIG. 77. BLOCKED WINDOW OF AMBULATORY

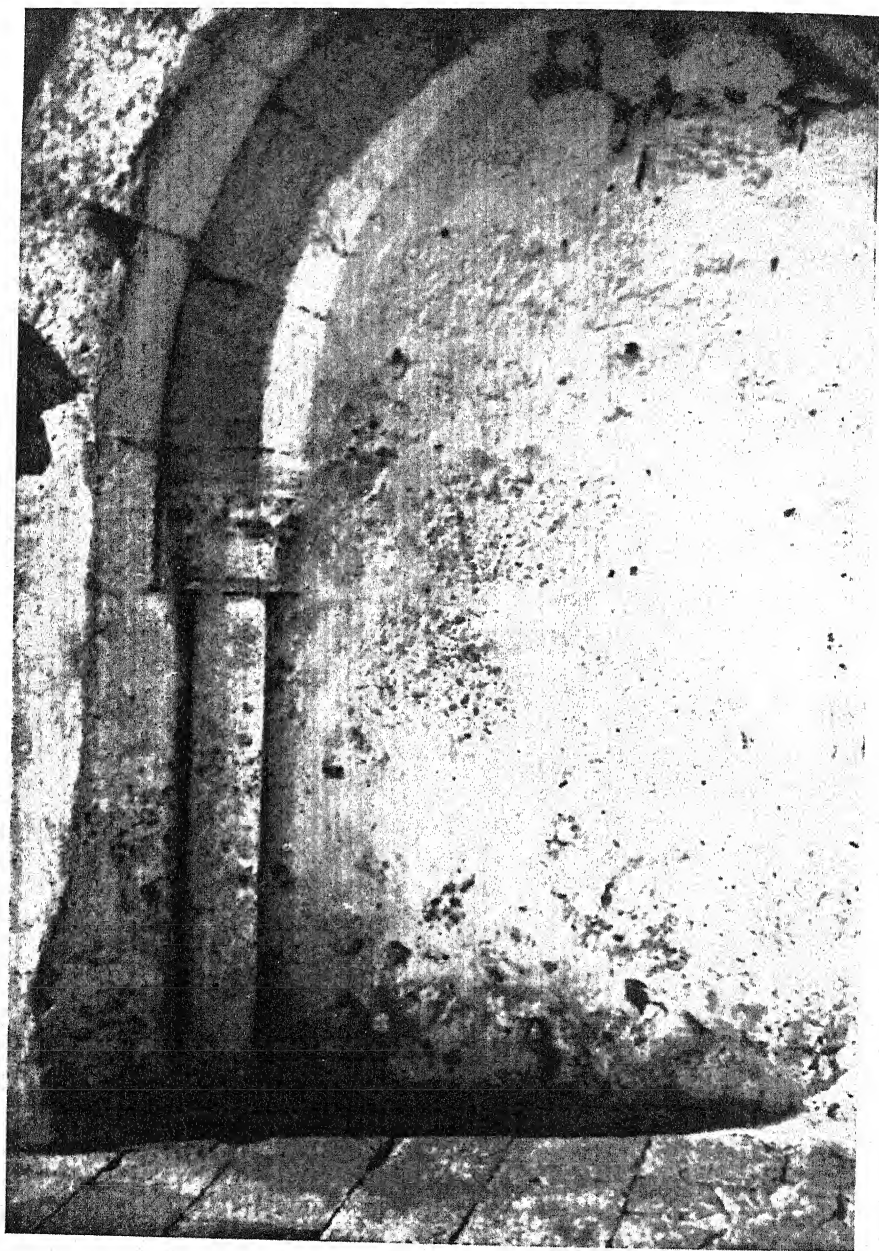
FIG. 78. BLOCKED WINDOW OF CENTRAL APSE CHAPEL

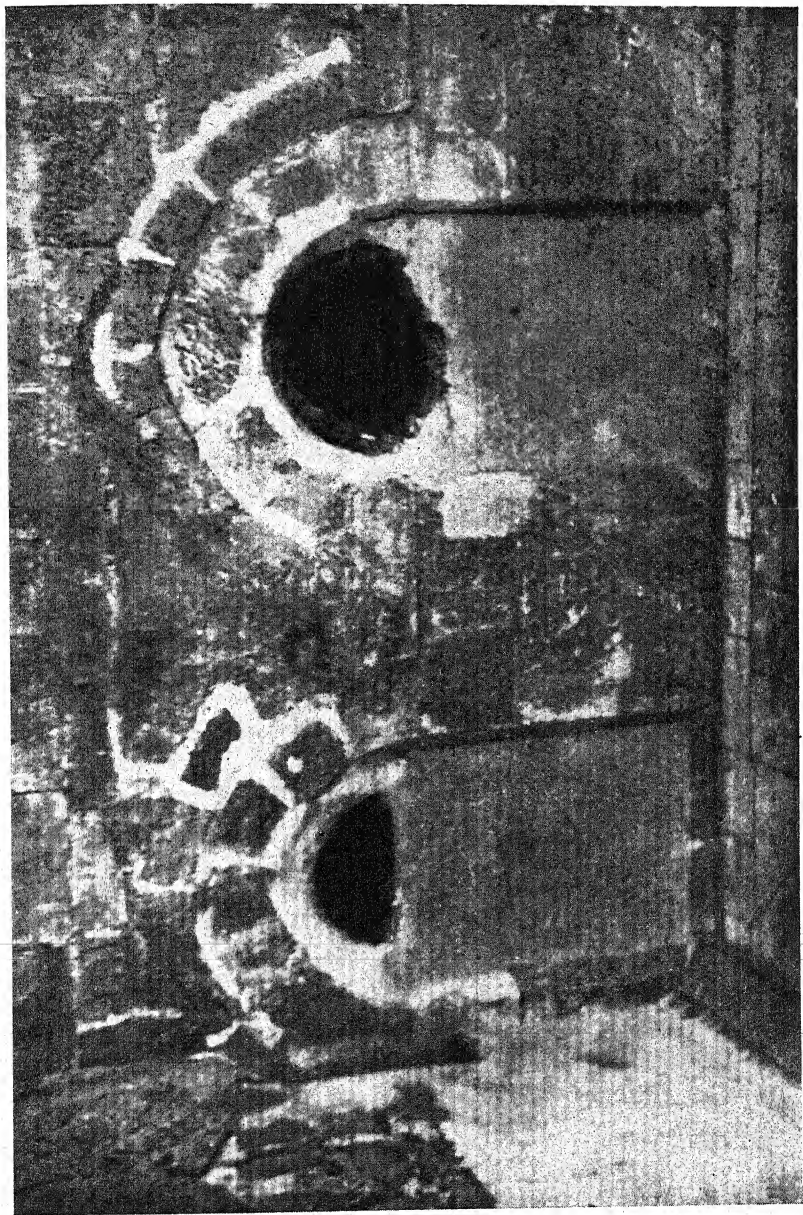
FIG. 79. PARTIALLY BLOCKED WINDOWS OF NORTH TRANSEPT

1. High vault North Transept North wall (2) (see Fig. 79).
2. High vault East arm North wall (1).
3. Eastern arm North wall—to Latin chamber (shuttered) (2).

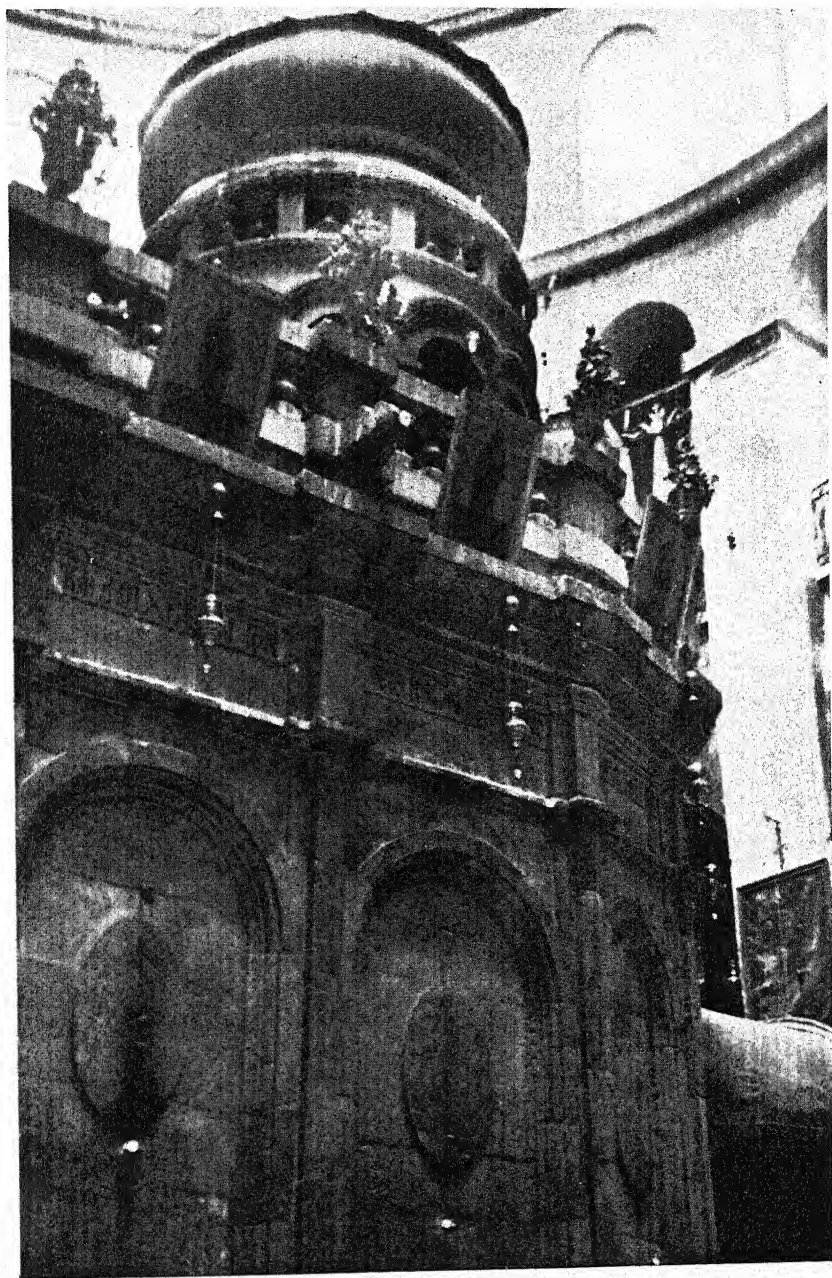
FIG. 119. THE EDICULE OF THE SEPULCHRE

As the edicule of the Sepulchre itself does not form part of the fabric, it has not been mentioned in the body of this report. Its state is, however, one of serious decay, and steps should be taken to secure it from sudden collapse.

It seems very doubtful whether its age is sufficient to justify its retention in the event of extensive repair or alternative demolition being in question. Its design (see Fig. 119) is completely out of keeping with the original Church, and would appear still more so if the suggested alterations take place, restoring to the building as far as possible its earlier form.
